Black Lab Aviation Services LLC - Eagleneck 1GA0

Date: 12/06/2022 Make: Piper Model: PA32-260 Reg: N4887S S/N: 32-7100011  
Tach: 6470.52 Hobbs: 2953.4

REPAIR OF DISCREPANT HOLE AND CRACK DAMAGE RH WING, MAIN SPAR,  
LOWER CAP AT APPROX WING STATION 30.00

PA-32-260 (7100011) /02

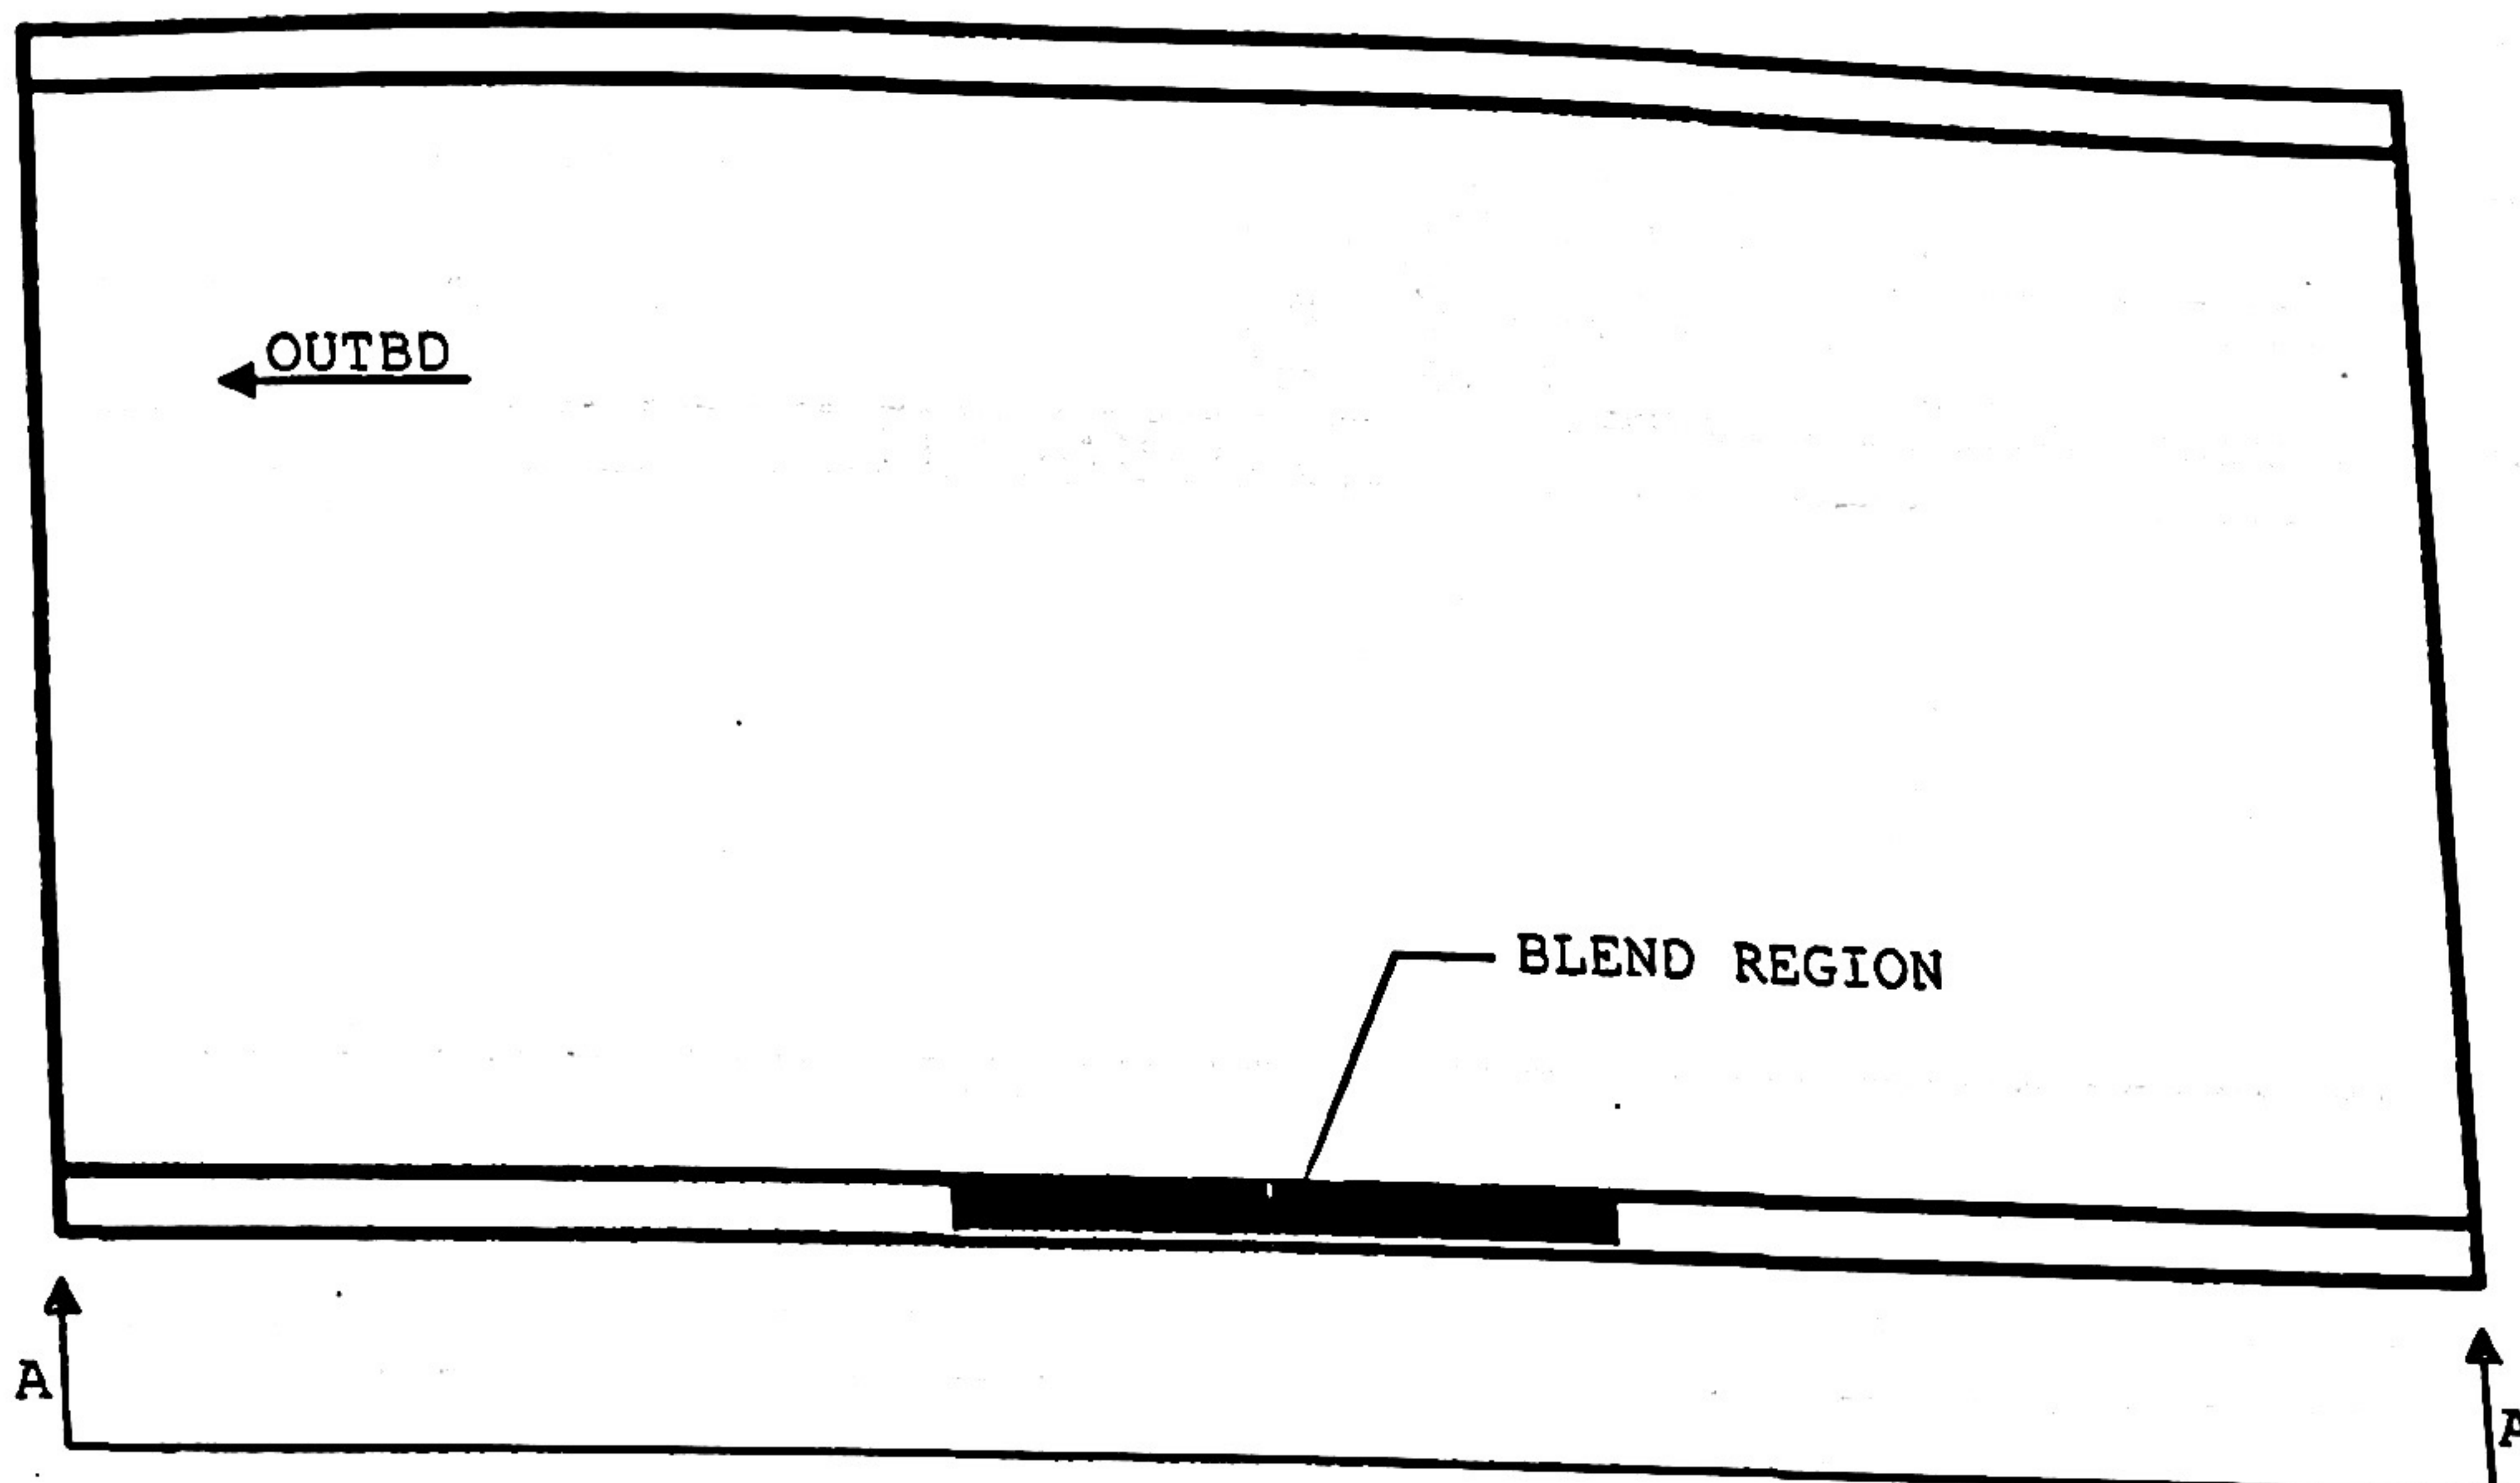
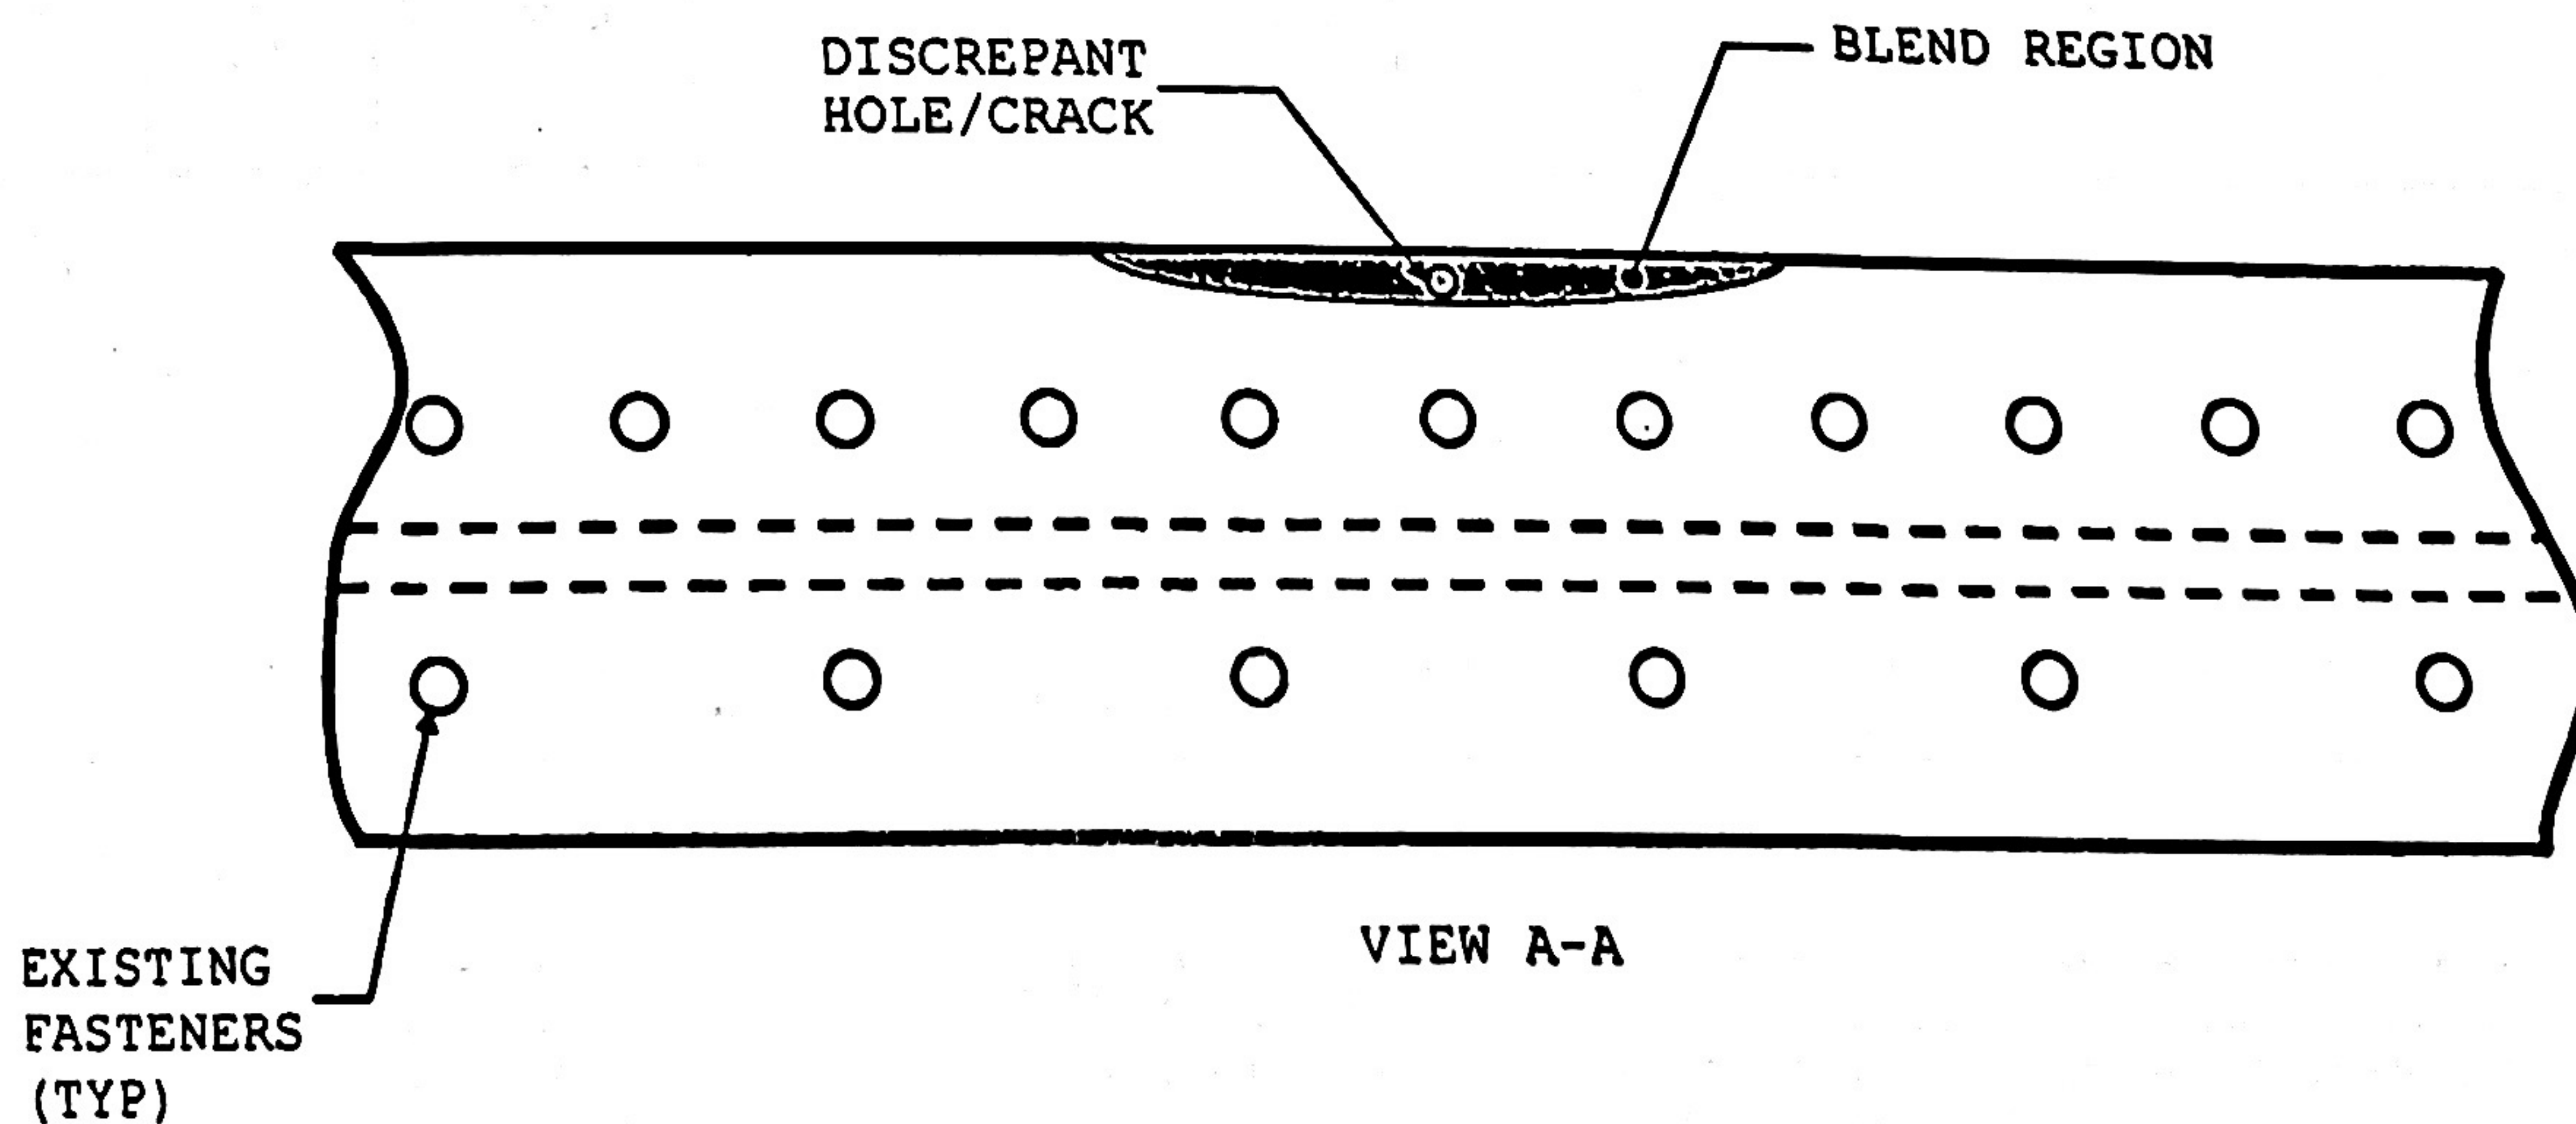
FIGURE 1: REPAIR SKETCH - BLEND

Performed repair of discrepant hole and crack damage right hand wing, main spar, lower cap at approximately wing station 30.00.

During inspection of the RH Wing, Main Spar, a discrepant fastener hole and crack damage was noted on the Lower Cap at approximately WS 30.

Inspected damaged area using fluorescent dye penetrant method. Blended area IAW Piper aircraft Engineering Order PA-32-260(7100011)/02 using a blend radius of .30" (minimum .25") and a blend depth of .26" (maximum .30"). Blended using approximately a 20:1 gradual transition between reworked area and non-reworked area.

The discrepant hole and crack is to be blended out and polished smooth at the rework location.

1. Remove discrepant hole and crack damage from the P/N 62070-07 RH Main Spar Assembly as shown in Figure 1.
  - a. Inspect for extent of cracking using fluorescent dye penetrant. Mark all crack indications.

- e. The repair shall present a smooth and gradual transition between the reworked area and the non-reworked area (at an approximate 20:1 width to depth ratio).

3. Final polish the repair area (this operation shall remove a negligible amount of material, polish only).
  - a. Use 320 grit sand paper or tool.
  - b. Minimum blend radius is 0.25 inch perpendicular to the part surface.

- c. The repair shall present a smooth and gradual transition between the reworked area and the non-reworked area.
  - d. The final surface finish is to be approximately RMS 63.

- e. If rework will exceed these depths discontinue repairs and report estimated required depth to Piper Engineering.
  - f. Clean, Alodine and epoxy prime all bare areas.
