TELEDYNE CONTINENTAL[®] AIRCRAFT ENGINE SERVICE INFORMATION LETTER

SIL99-1

SUBJECT: ENGINE PRESERVATION FOR ACTIVE AND STORED
AIRCRAFT

Company
Manufacturer CESSNA AIRCRAFT CORP.
Model 182L
Tail # N42279
Serial # 18258940
Current Time 3425
Total Time 5521
A/C Cert. Date 3-20-68

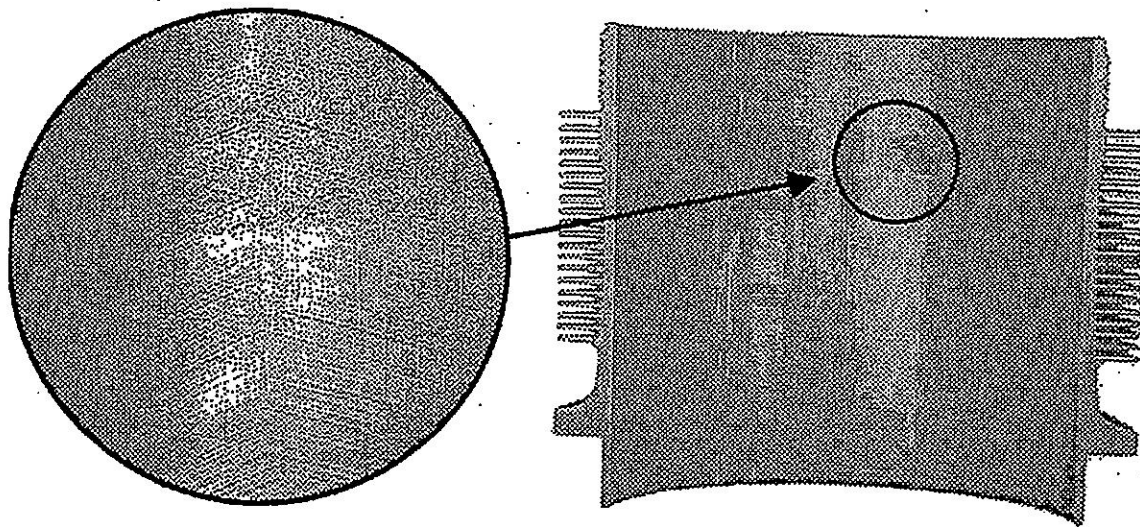
FIGURE 1

Light Rust Formation, Hone Not Affected.

Light rust signatures which have not pitted the cylinder wall, or rust indications above the top ring travel area, are not usually cause for concern. See Figure 1. Severe rust will pit the barrel wall and can damage rings. See Figure 2. Such damage will usually be evident by low differential compression checks and high oil consumption. TCM'S WARRANTY DOES NOT COVER DAMAGE FROM RUST. Rust damage must be prevented by the operator and/or maintenance facility.

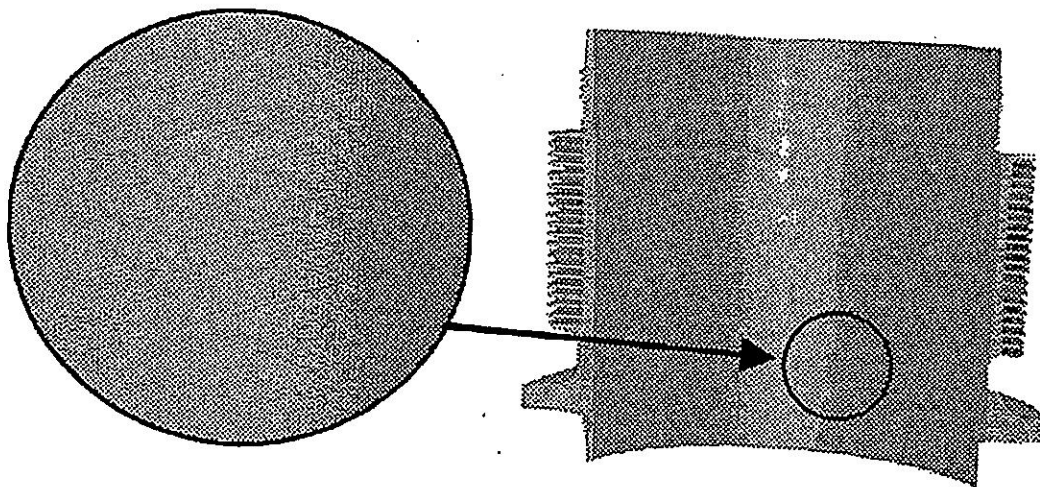
FIGURE 3

New Steel Cylinder Bore

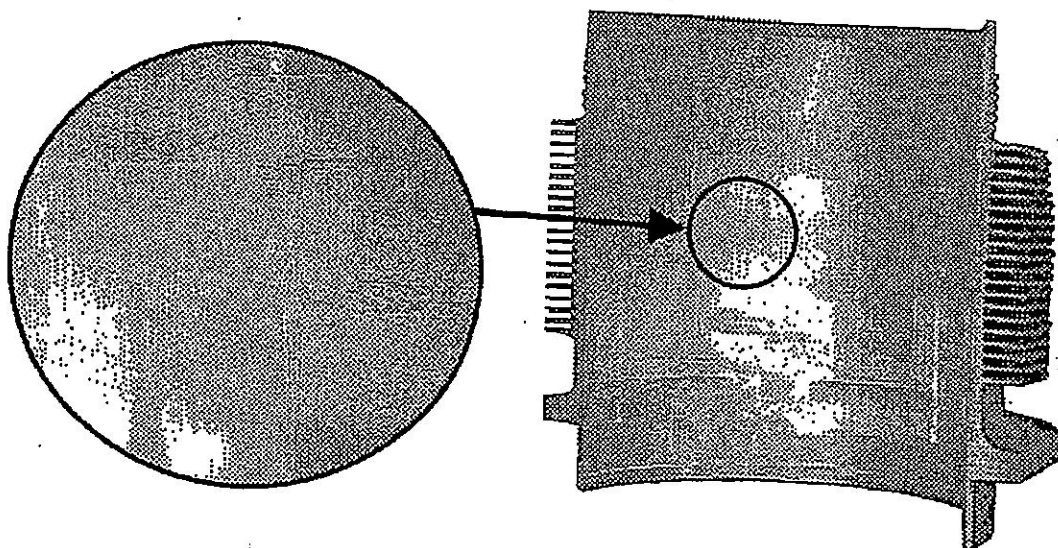
FIGURE 4

Typical Cylinder Bore At TBO

Scratches or grooves that extend in the direction of piston travel can result from contamination and may lead to low differential compression checks and high oil consumption. Heavy bore wear with a complete loss of visible hone pattern over the full ring travel can result from over-temperature operation or abrasive wear. See Figure 5. These signatures, in conjunction with low differential compression checks or high oil consumption, generally indicate cylinder repair or replacement or, at minimum, call for more frequent condition inspections.

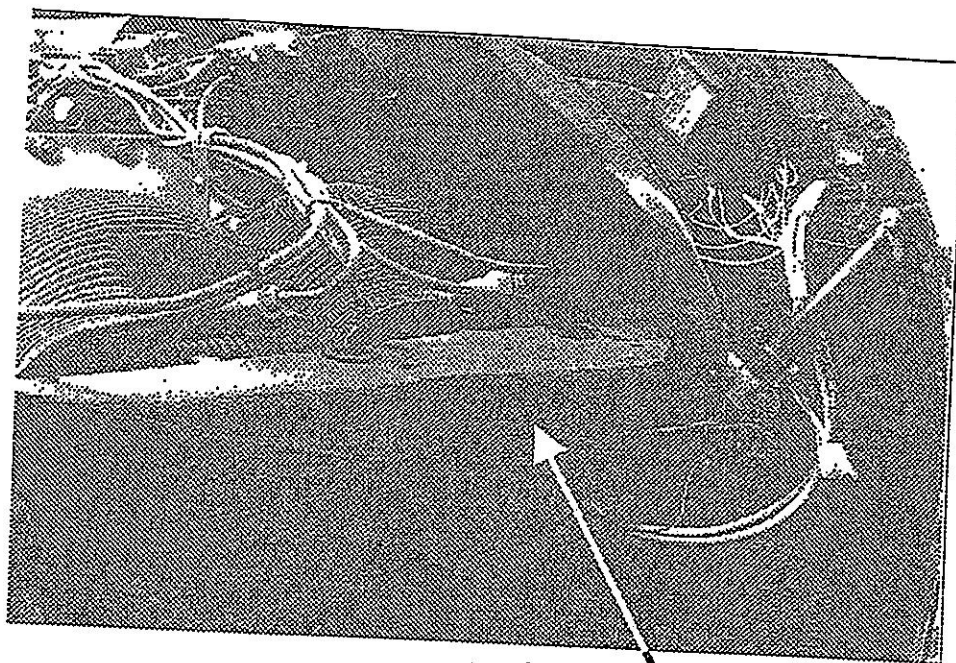
Investigations into cylinder service life issues found that maintenance of cylinder and oil cooling systems (incorrect and improperly fitting baffles) were factors in premature cylinder removals. To understand the importance of this cooling control, note that approximately one third of the energy of the fuel used is transferred as heat to the structure (cylinder head, barrel, crankcase, etc.) and oil. THE AMOUNT OF HEAT ENERGY THAT MUST BE REMOVED BY THE COOLING AIR IS APPROXIMATELY EQUAL TO THE HORSEPOWER THAT IS DRIVING THE PROPELLER. This is why failure of the cooling baffles to perform efficiently can lead to rapid and significant deterioration of the cylinders and other engine components.

Peripheral Baffle Seals Improperly Positioned

- a. Check baffles for condition, correct position, and proper contact with cowl.
- b. Repair or replace worn or distorted baffles.
- c. Check and adjust inter-cylinder baffles to ensure a tight fit.

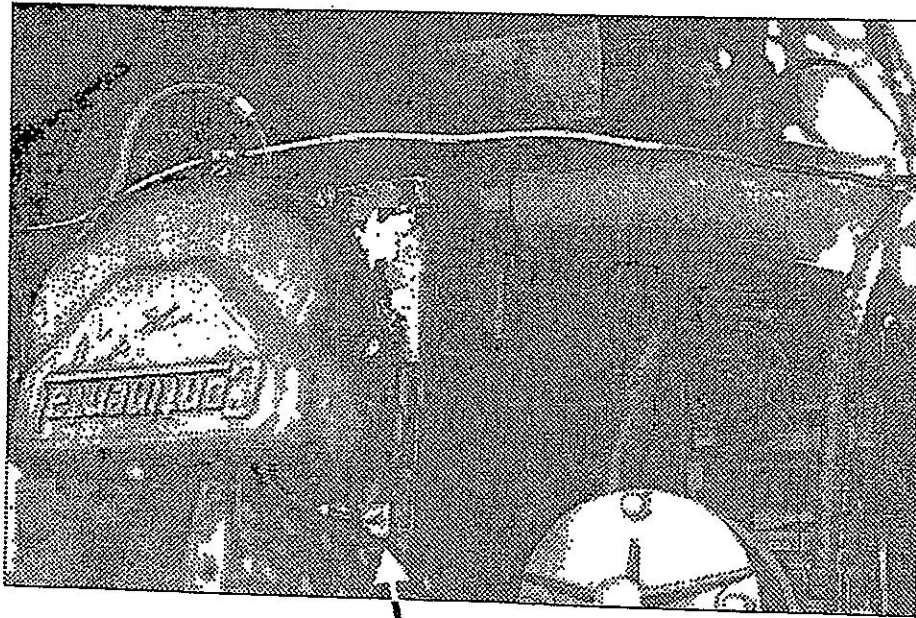
Air and Side Batties with
Air Gaps
