**Prime Turbines**  
**485 Airport Rd**  
**Butler, PA 75006 USA**  
**972-406-2100**

<b>Customer:</b> E & E Aviation	<b>Purchase Order Instructions:</b> Comply with Pre-Buy Bore-scope Inspection	<b>Date:</b> 12/16/2021	
<b>Description:</b> Turbo-Prop Engine	<b>Manufacture:</b> Pratt & Whitney Canada	<b>Model or Part Number:</b> PT6A-52	<b>Serial Number:</b> PCE-RX0170
<b>Time Since New (TSN):</b> Aircraft Hobbs 7047	<b>Cycles Since New (CSN):</b>	<b>Time Since Overhaul (TSO):</b>	<b>Time Since (H.S.I):</b>

**Inspection detail:**

Bore-scope inspection limited to hot section and 1<sup>st</sup> stage compressor:

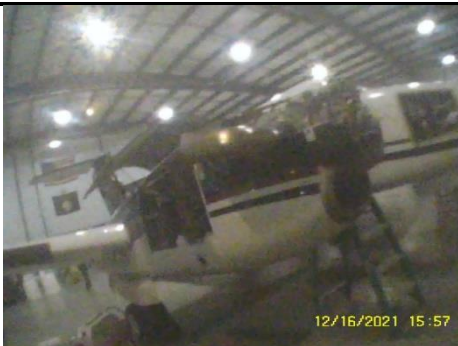
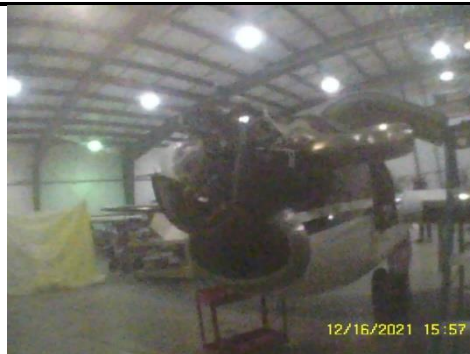
Engine View 2

- 1) Engine external – Good condition, normal expected for time in service.
- 2) Compressor inlet and screen – Screen serviceable condition and rubber in serviceable condition

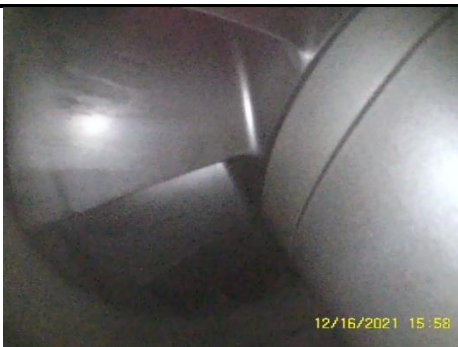
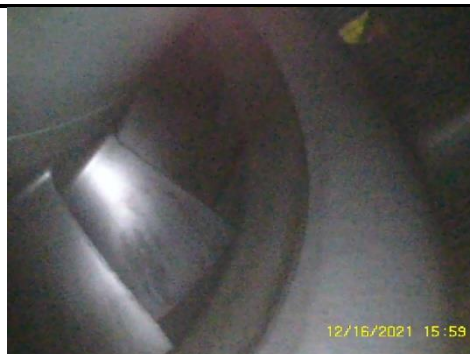
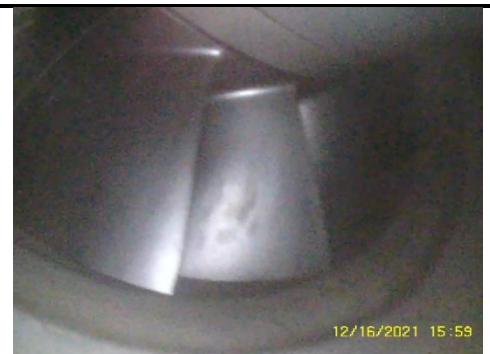
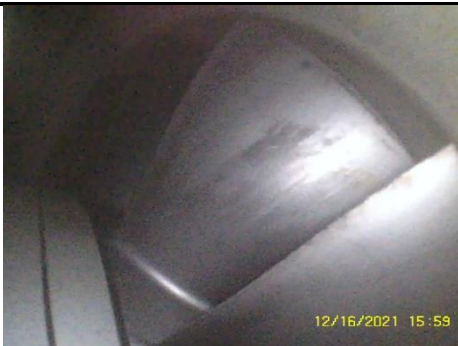
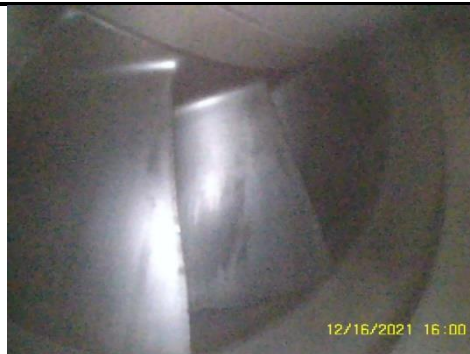
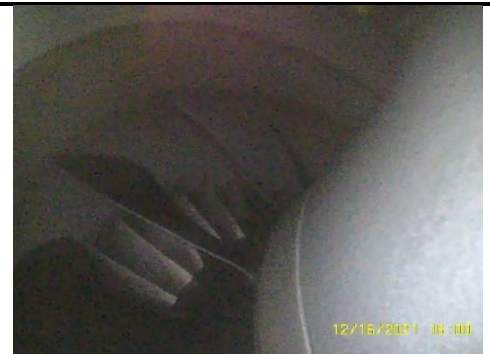
1<sup>st</sup> Stage Compressor

- 3) Compressor rear hub and 1<sup>st</sup> stage blades – Minor acceptable nicks and erosion with no action required. Minor corrosion and dirty
- 4) Compressor #1 Vane and Shroud – Good condition, with surface corrosion and coating loss. Coating loss normal for Cadmium Plating

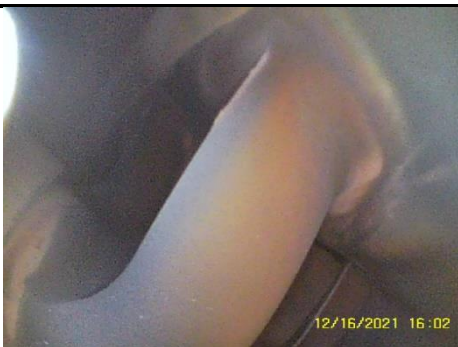
CT Vane Ring

- 7) C.T. Vane Ring – Normal with minor / acceptable hot gas erosion and coating loss. Hairline cracks noted with No action required. There is some TBC that has attached to the CT Vane and Blades

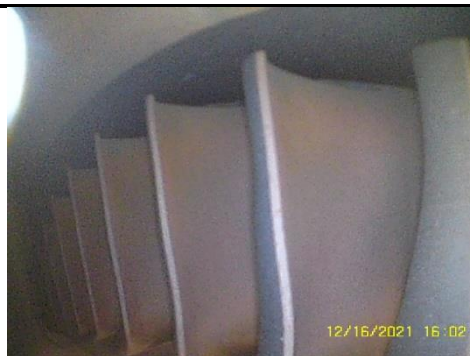
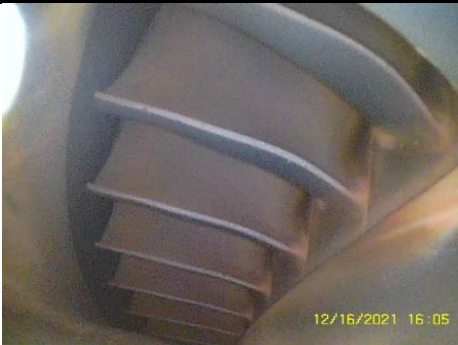
- 5) Gas / Gen Case – Good condition with no defects observed
- 6) Compressor Turbine / Blades – Run time buildup of soot/elements and minor discoloration on all CT blades. Also some TBC from SED has adhered to CT Blades

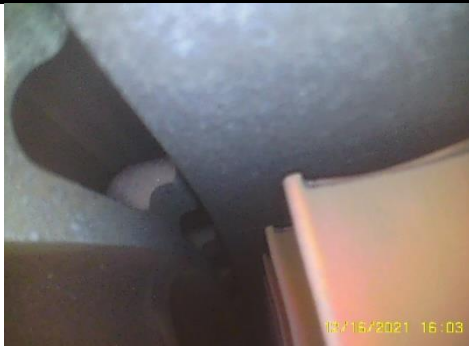
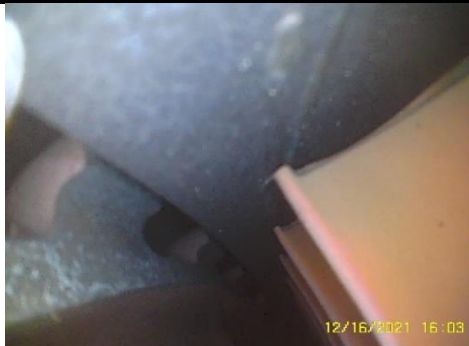
<p>12/16/2021 16:03</p> <p>CT Blades and Shroud Segments</p>

- 8) Small exit duct – Normal with localized heat concentration and coating loss with minor burning noted. All acceptable at this time
- 9) Shroud housing and segments. – Shroud housing found in normal condition and minor blade rub. All acceptable at this time.

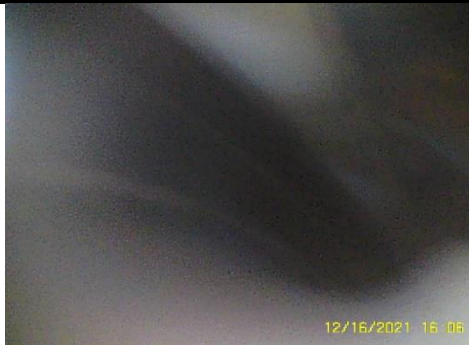
<p>12/16/2021 16:06</p> <p>Outer Combustion Liner and Small Exit Duct</p>

- 10) Combustion Liner—with minor amounts of carbon and build up noted. No action required at this time
- 11) Power Turbine Blades / Stator – Normal with blades for time in service and no action required.
