TELEDYNE CONTINENTAL[®] AIRCRAFT ENGINE SERVICE INFORMATION LETTER

SIL99-1

SUBJECT: ENGINE PRESERVATION FOR ACTIVE AND STORED
AIRCRAFT

Company
Manufacturer CESSNA AIRCRAFT CORP.
Model 182L
Tail # N42279
Serial # 18258940
Current Time 3425
Total Time 5521
A/C Cert. Date 3-20-68

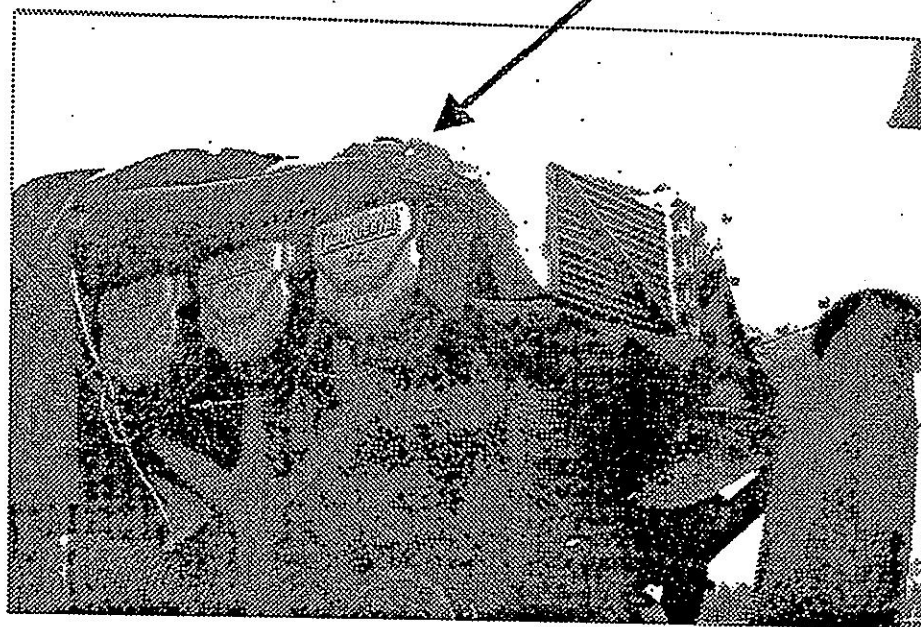
Peripheral Baffle Seals Improperly Positioned

- a. Check baffles for condition, correct position, and proper contact with cowl.
- b. Repair or replace worn or distorted baffles.
- c. Check and adjust inter-cylinder baffles to ensure a tight fit.

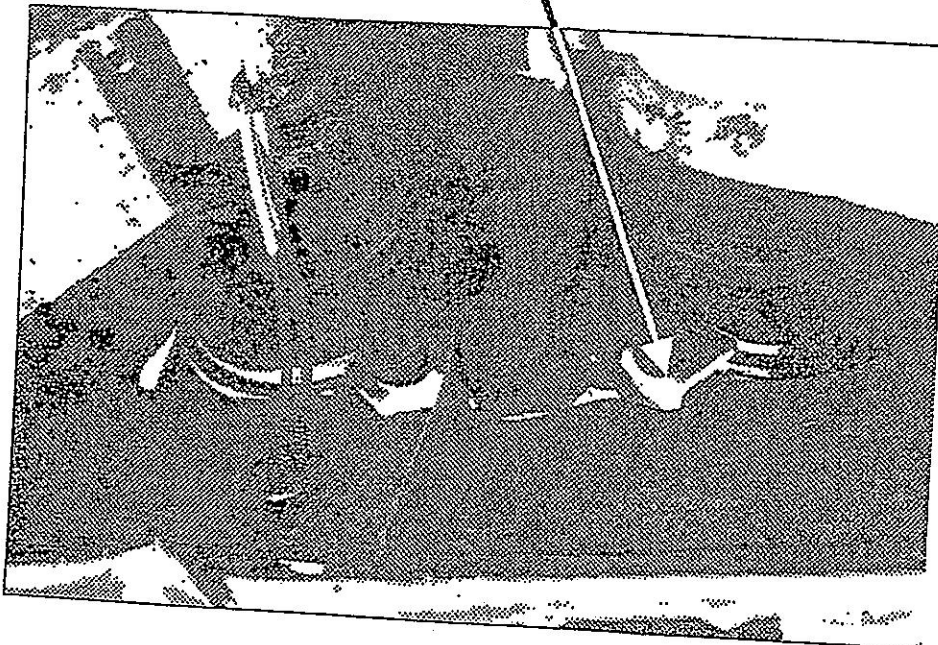
Air and Side Batties with
Air Gaps
