**Prime Turbines**  
**485 Airport Road**  
**Butler, Pennsylvania 16002 USA**  
**(724) 586-0124**

<b>Customer:</b> E & E Aviation	<b>Purchase Order Instructions:</b> Comply with Pre-Buy Bore-scope Inspection	<b>Date:</b> 12/16/2021	
<b>Description:</b> Turbo-Prop Engine	<b>Manufacture:</b> Pratt & Whitney Canada	<b>Model or Part Number:</b> PT6A-52	<b>Serial Number:</b> PCE-RX0169
<b>Time Since New (TSN):</b> Aircraft Hobbs 7047	<b>Cycles Since New (CSN):</b>	<b>Time Since Overhaul (TSO):</b>	<b>Time Since (H.S.I):</b>

**Inspection detail:**

Bore-scope inspection limited to hot section and 1<sup>st</sup> stage compressor:

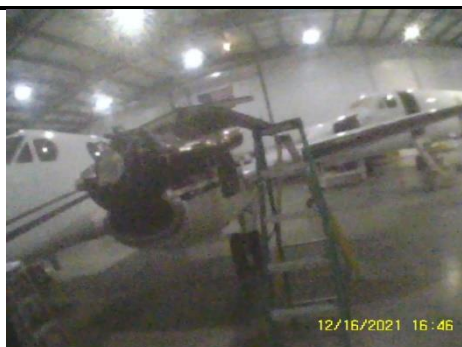
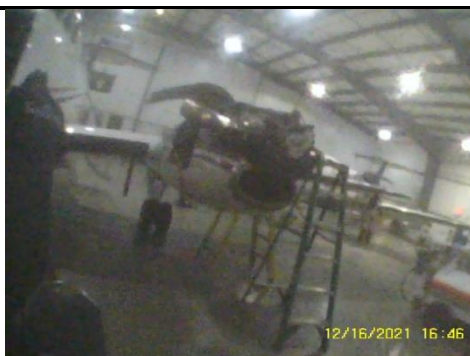
- 1) Engine external – Good condition, normal expected for time in service.
- 2) Compressor inlet and screen – Screen serviceable condition and rubber in serviceable condition

Engine View 1

Engine View 2

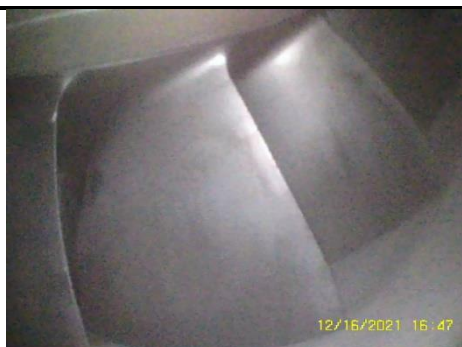
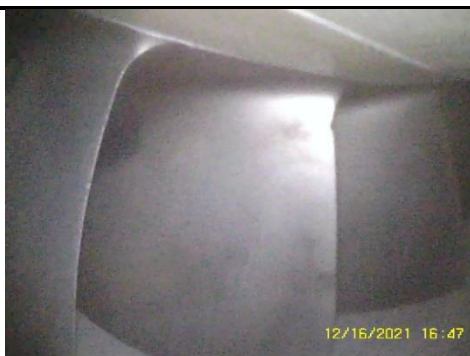
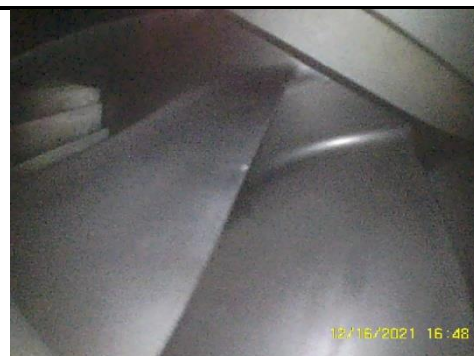
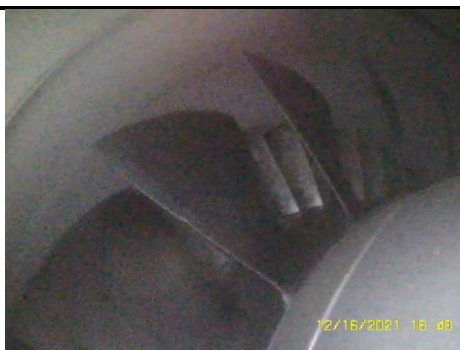
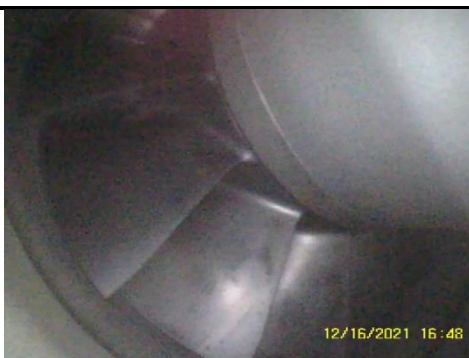
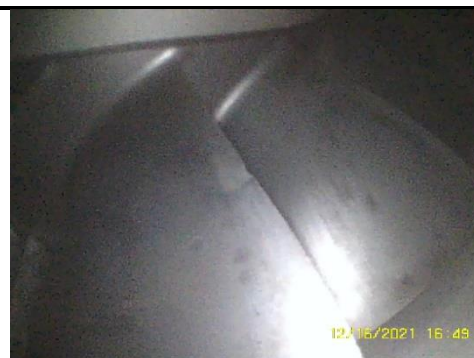
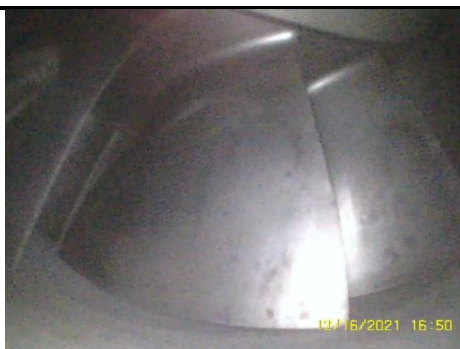
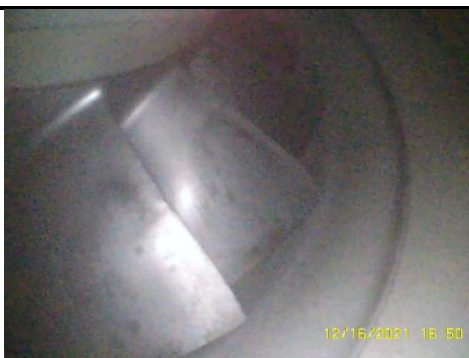
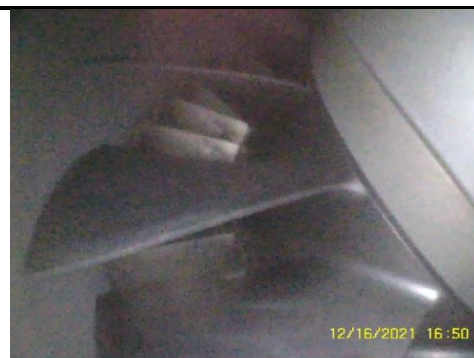
- 3) Compressor rear hub and 1<sup>st</sup> stage blades – Minor acceptable nicks and erosion with no action required. General smoothing of leading edge recommended in field. No action required at this time. Minor corrosion and dirty

1<sup>st</sup> Stage Compressor

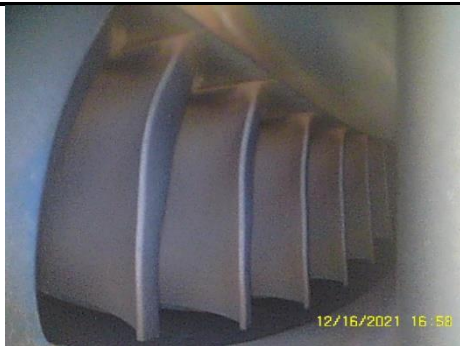
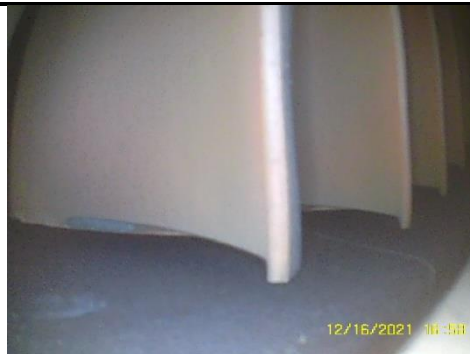
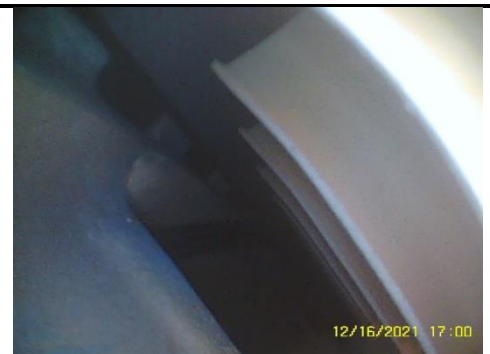
- 6) Compressor Turbine / Blades – Run time buildup of soot/elements and minor discoloration on all CT blades. Also some TBC from SED has adhered to CT Blades

CT Blades

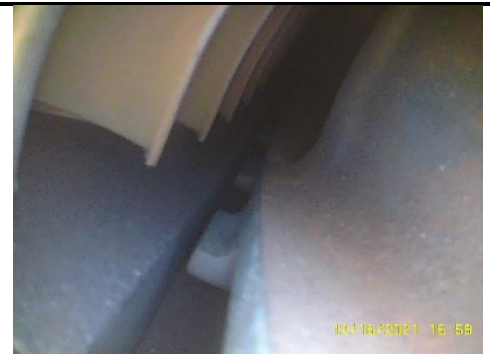
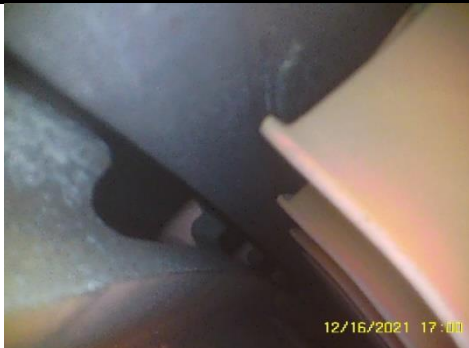
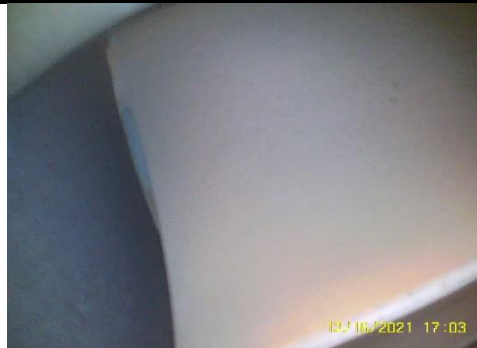
- 9) Shroud housing and segments. – Shroud housing found in normal condition and minor blade rub. All Acceptable at this time
- 10) Combustion Liner—with minor amounts of carbon and build up noted. No action required at this time

CT Blades and Shroud Segments

<p>12/16/2021 17:01</p> <p>CT Blades and Shroud Segments</p>

<p>12/16/2021 17:03</p> <p>CT Blades and Shroud Segments</p>

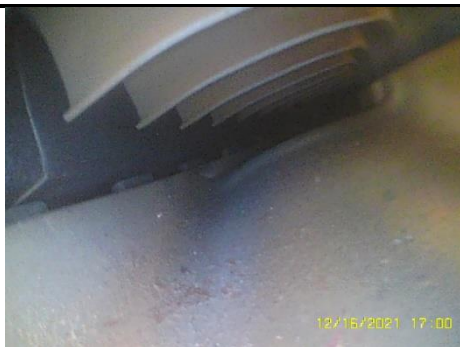
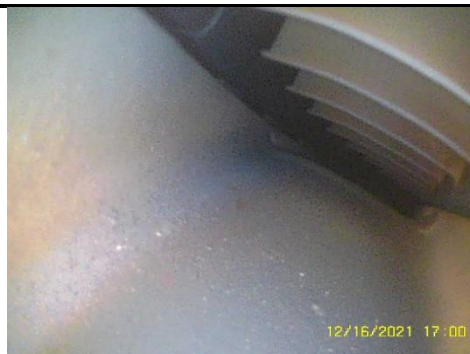
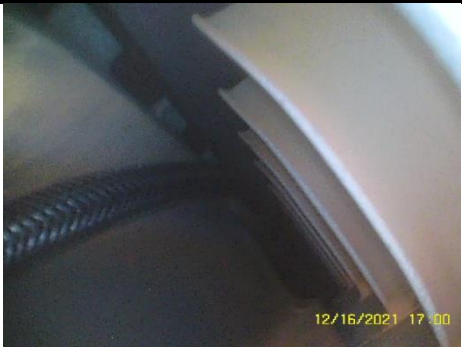
- 7) C.T. Vane Ring – Normal with minor / acceptable hot gas erosion and coating loss. There is some TBC that has attached to the CT Vane and Blades
- 8) Small exit duct – Normal with localized heat concentration and coating loss. All acceptable at this time

CT Vane Ring and CT Blades

<p>12/16/2021 17:00</p> <p>CT Blades and CT Vane Ring</p>

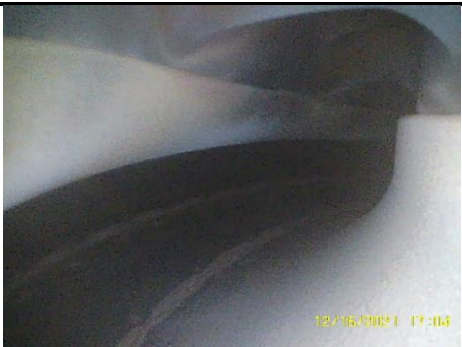
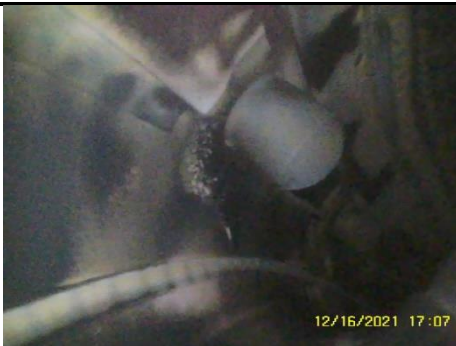
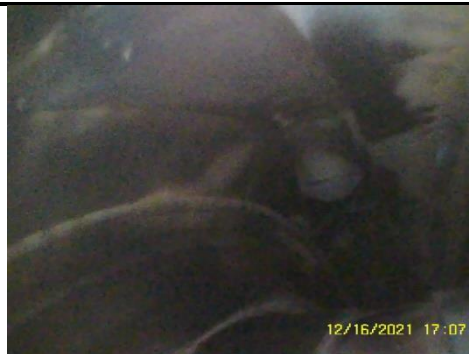
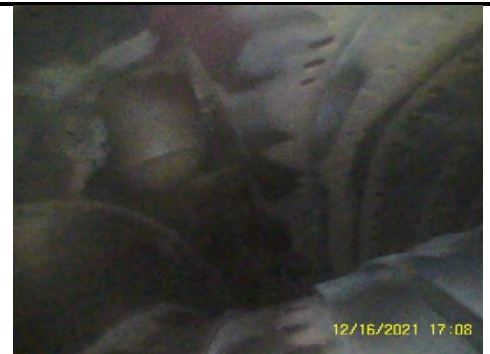
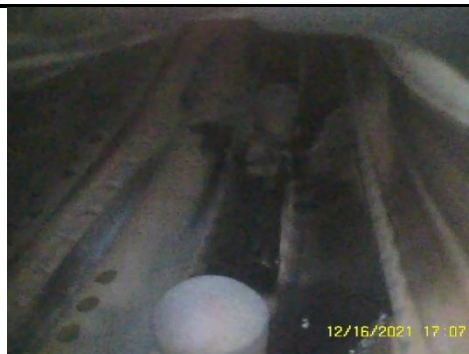
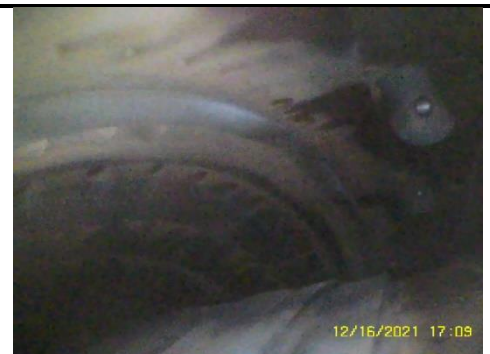
<p>12/16/2021 17:04</p> <p>Outer Combustion Liner</p>

Outer Combustion Liner

Outer and Inner Combustion

Inner and Outer Combustion Liner

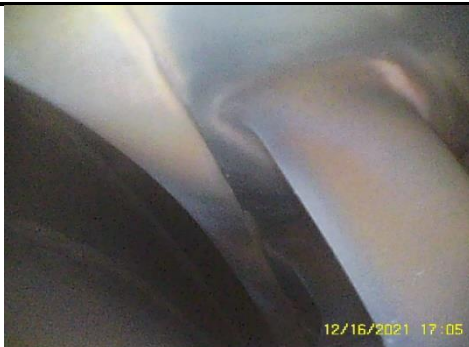
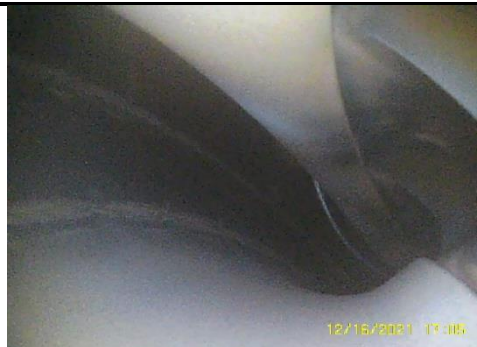
<p>12/16/2021 17:05</p> <p>Small Exit Duct and CT Vane</p>

<p>12/16/2021 17:06</p> <p>Outer Combustion Liner and Small Exit Duct</p>

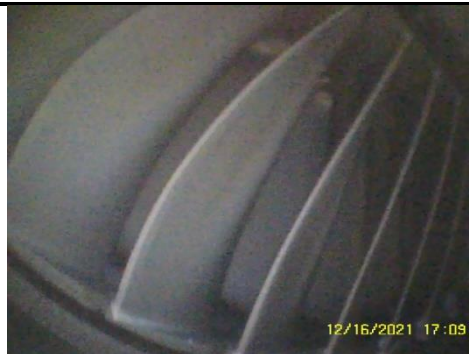
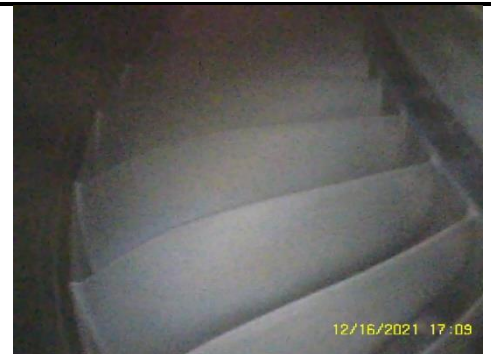
- 11) Power Turbine Blades / Stator – Normal with blades for time in service and no action required.
- 12) Engine is normal condition for time in service

PT Blades
